# Kurtun Dam oscillate characterization with landslide possible effect detection using InSAR observations

**Keywords** Landslide detection · Dam monitoring · Multi-temporal SAR · InSAR · Time series

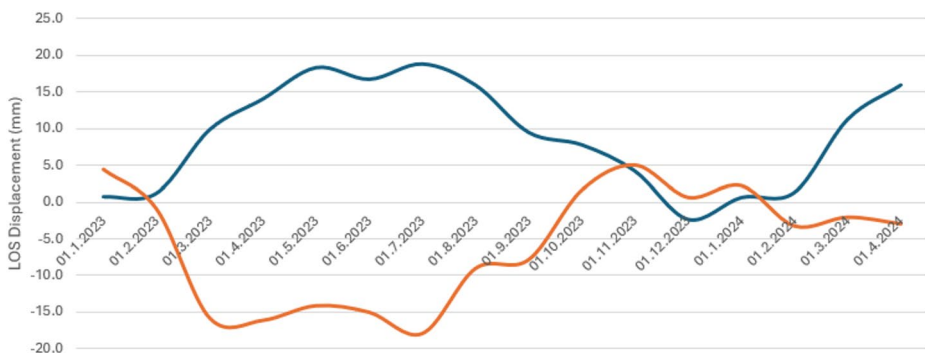
**Fig. 3** The displacement rates at monitoring point P3 in dam crest, as observed through PS-InSAR analysis, are presented with descending LOS results in orange and ascending LOS results in blue

To assess the temporal displacement characteristics of the Kurtun Dam, several monitoring points were strategically positioned. In the dam's central top region (Point P3), displacement rates exceeded 17 mm/year (Fig. 3). Points P1 and P2, located on either side of the embankment, showed minimal displacement with rates not exceeding 3 mm/year. The midpoint of downstream slope (Point P4) exhibited a moderate yearly displacement rate of approximately 6 mm. Finally, point P5, situated at the foot of the dam slope, also showed a low displacement rate, with the annual rate remaining below 1 mm/year (Fig. 3).

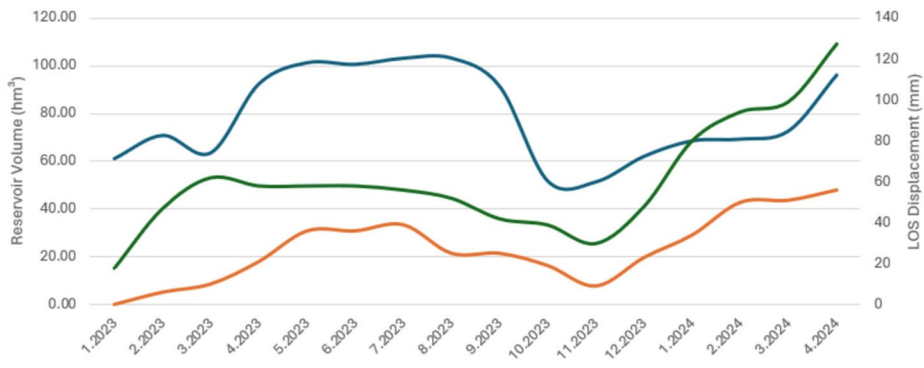
**Fig. 9** The displacement rates at monitoring point in dam crest PS are presented with descending LOS results in orange, ascending LOS in green, and reservoir water volume measurements in blue

and the aging of materials. Periodic variations in water pressure and temperature induce transient deformations in dam structures, whereas self-weight and material aging contribute to long-term compaction and consolidation, leading to gradual increases in deformation over time. The deformation patterns of the dam slope and its base correlate with changes in water levels indicating a clear and significant relationship between displacement and water levels, indicating that the dam is generally in a stable condition (Fig. 9).
